Buyer's Choice Home Inspections The Best Home Inspection At The Best Price

Confidential Inspection Report

1343 W Glenmere Dr Chandler, AZ 85224

Prepared For Pam & Steve Sellers

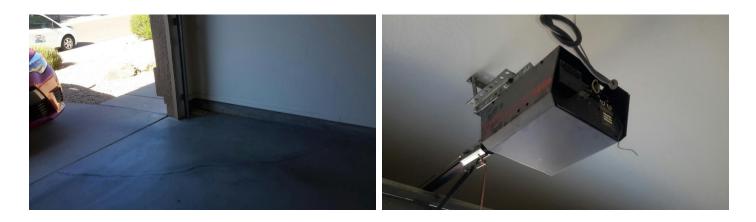
3.13 - The garage door opener is an older type that does not have a infra red beam you may want to have it updated to a newer quieter opener.

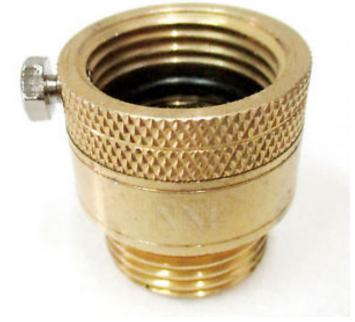
Hose Bibs

4.22 - The hose bibs that I tested are functional, but do not include anti-siphon valves. These valves are relatively inexpensive, are required by current standards. However, I may not have located and tested every hose bib on the property.

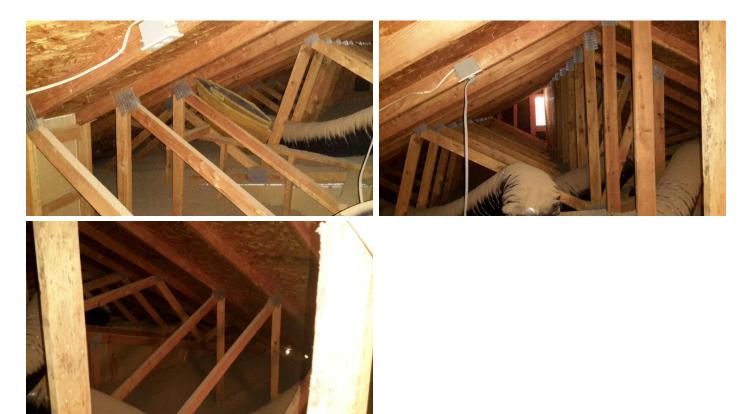
7.2 - The attic was evaluated by direct access to easily accessable areas, and viewed from easy vantage points near the catwalk if it has one.

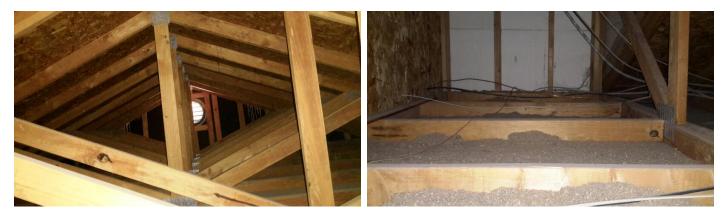
7.11 - We evaluated the attic from the access due to inadequate clearance within.

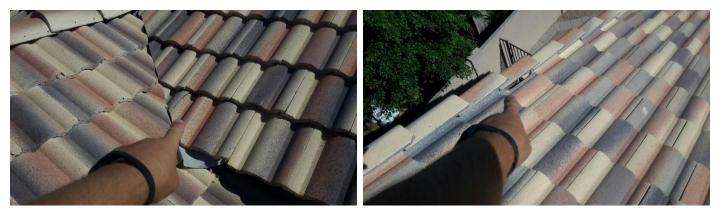
9.4 - Viewed at least 10 out of place roof tiles that should be evaluated and repaired or replaced as necessary by a qualified roofer or technician. These issues should be repaired to help prevent wearing of the protective layer beneath the roof covering or possible moisture intrusion within the residence. They were located at the very top middle north side.

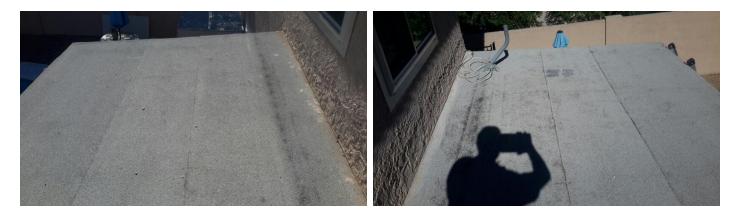
9.7 - The rear patio roof is in primary stages of decline and it should be monitored or further evaluated from a roofer to see what future costs will be for replacement.

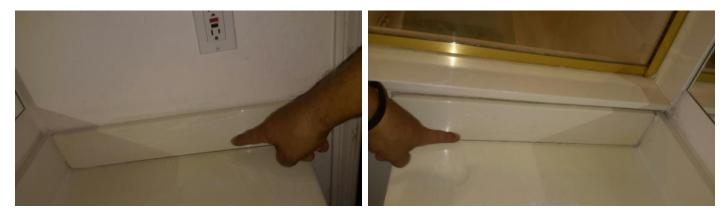
12.8 - In the master bedroom there is a typical separation between the sink countertop and the back-splash, which should be sealed to forestall moisture intrusion between the cabinet and the wall.

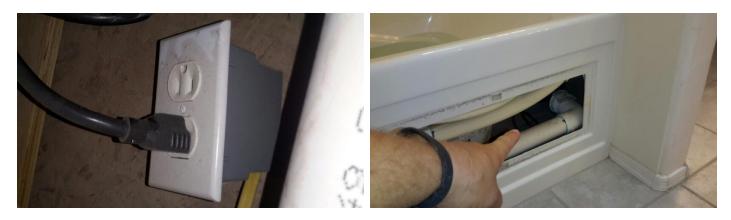
12.12 - The hydro-spa does not appear to have ground fault protection, which is an essential safety feature that should be be verified as being present or added.

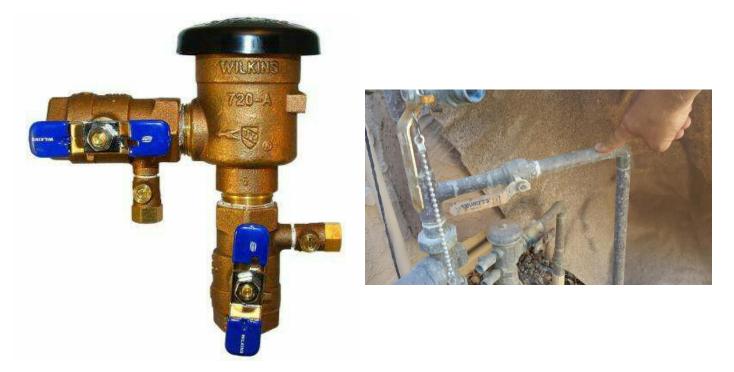
16.10 - The self-leveling automatic filling pool water supply is missing and anti-siphon valve at its connection. I recommend service as necessary from a qualified contractor.

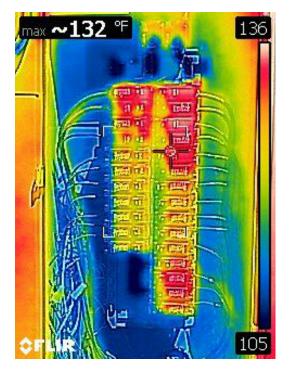
Electrical

17.2 - The thermal image of the electrical breakors and electrical within the panel are in use but within normal tempurature range.

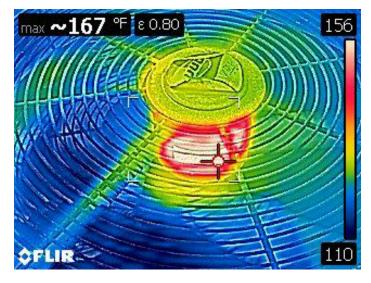
Air Conditioner Coil

17.3 - The Air conditioner(s) were scanned with the thermal camera and it appears to be operating normal with no signs of the fan bearings overheating.

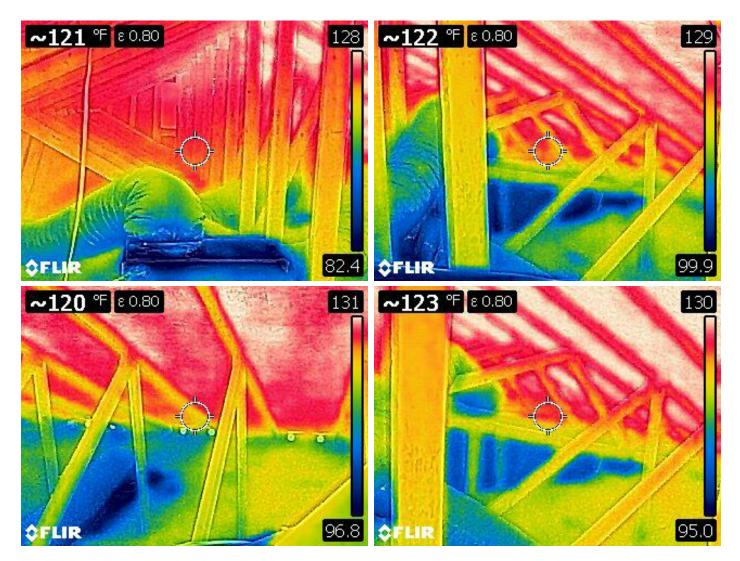
Attic

17.4 - Components within the attic was scanned by thermal camera and they appear to all be working as normal, with no immediate signs of rodents, abnormal leaking HVAC pipes, wet spots etc.

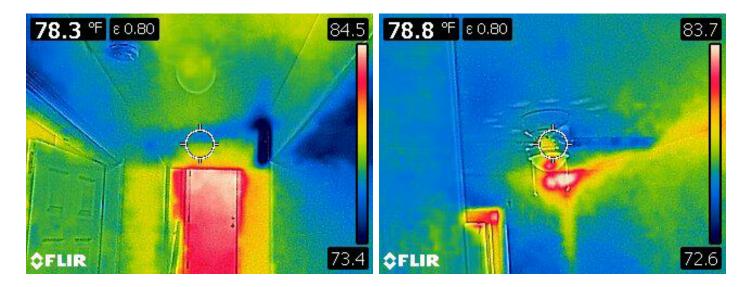
Walls- Basic

17.5 - There were a few spots that wind has blown back insulation, or insulation is missing you may want to have a contractor replace the insulation in these areas for improved efficiency.
