**Buyer's Choice Home Inspections**  
**The Best Home Inspection At The Best Price**

## Confidential Inspection Report

10815 W Northern Ave, unit 101  
Glendale, AZ 85307

03/02/2017 02:30 PM - 04:30 PM

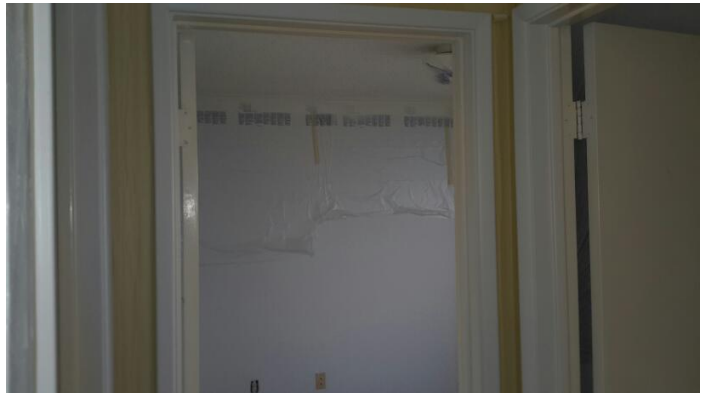
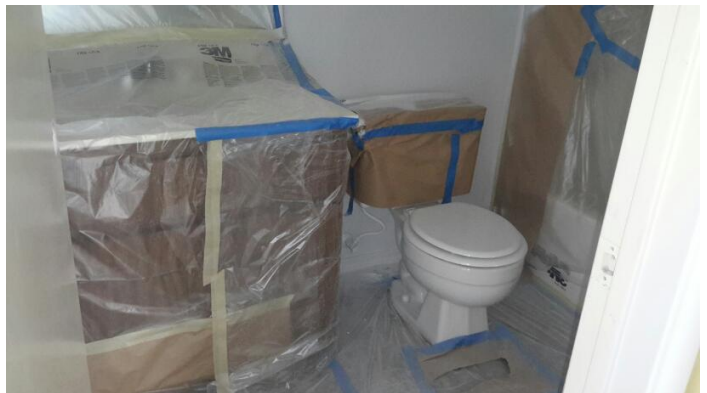
It was currently being painted and recepticle covers, door knobs, fire alarms etc have been all removed for painting and should all be re installed when finished.

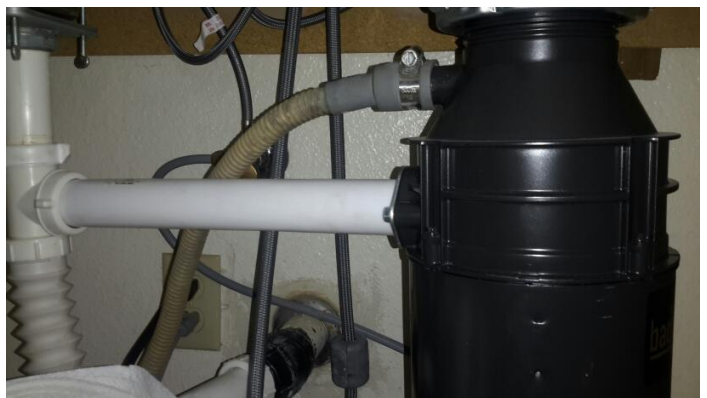
2.2 - The dishwasher does not have a proper high loop in the drain line at the garbage disposal and one should be added. The drain line should be raised 4-6 inches above the garbage disposal inlet to create a high loop that should help prevent the possibility of contaminants back flowing from the disposal into the dishwasher and to especially avoid unpleasant smells.

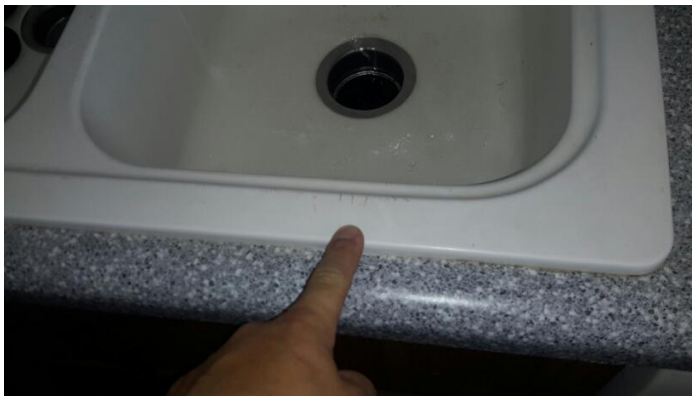
2.4 - The kitchen sink has typical cosmetic damage that you may wish to view for yourself.

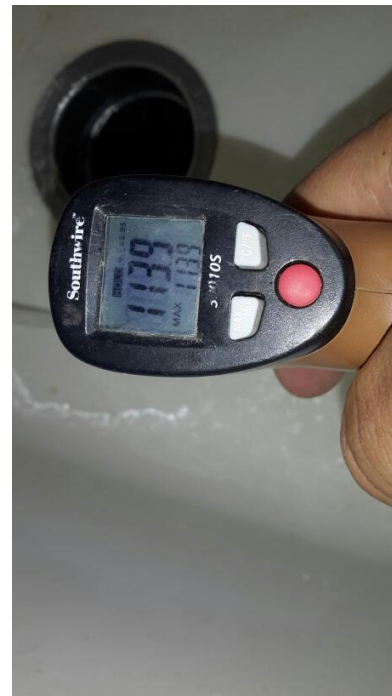
2.6 - The Water temp at the Kitchen Faucet is Currently 113.9 The U.S. Consumer Product Safety Commission (CPSC) urges all users to keep their water heater temps to 120 degrees Fahrenheit for scalding and bacteria prevention reasons.

2.7 - The kitchen faucet is loose and difficult to rotate and should be secured or repaired as necessary .

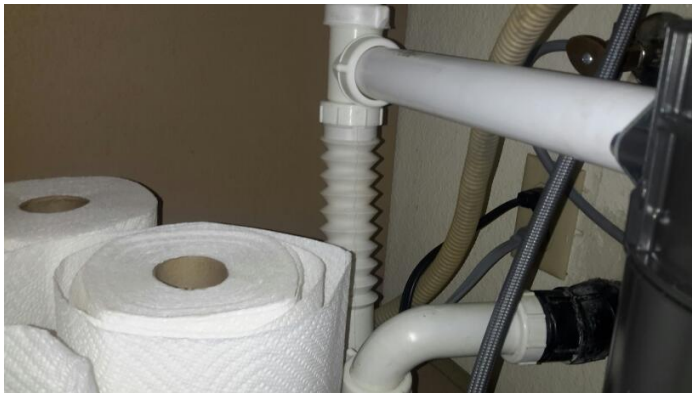
2.8 - The kitchen sink employs an unconventional flexible drainpipe that could contribute to blockages.

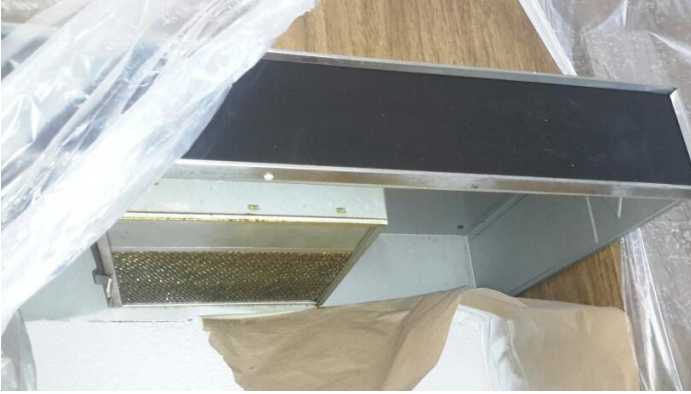
2.16 - The kitchen cooktop light did not respond and needs service. Maybe a bad light bulb?

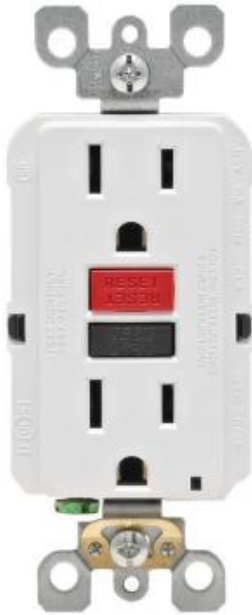
2.17 - All of the countertop outlets are functional and grounded. When this house was built (pre 1987) GFCI outlets were not required. Current modern homes all have GFCI protected outlets in the kitchen you may elect to have them updated for safety reasons. All outlets in the kitchen should have GFCI except for the fridge.

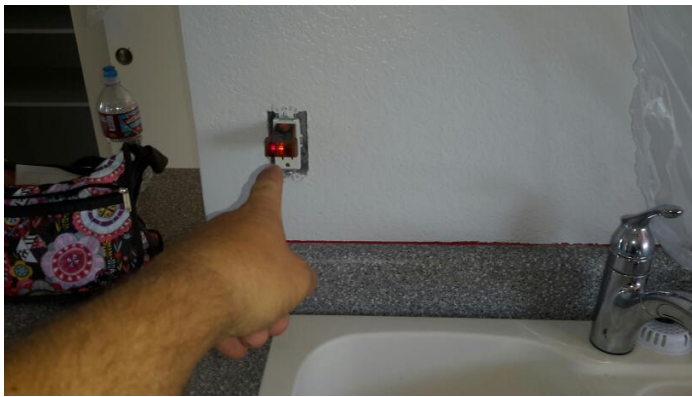
2.18 - A kitchen outlet has a hot/neutral reverse and should be further evaluated by a qualified electrician for service or replacement as necessary.

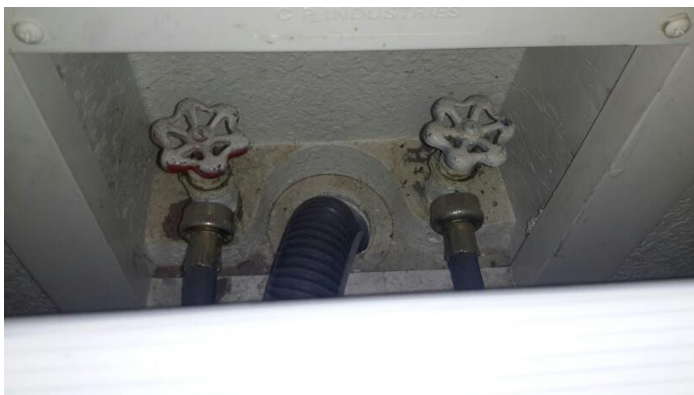
3.5 - The washing machine valves are older gate style valves. These valves are prone to failing and leaking as they age, especially if they are older. Since washing machine valves are rarely used, I recommend using caution when turning them on or off, as leaking may occur. To avoid possible leaking or valve failure, I recommend replacing these gate valves with newer ones.

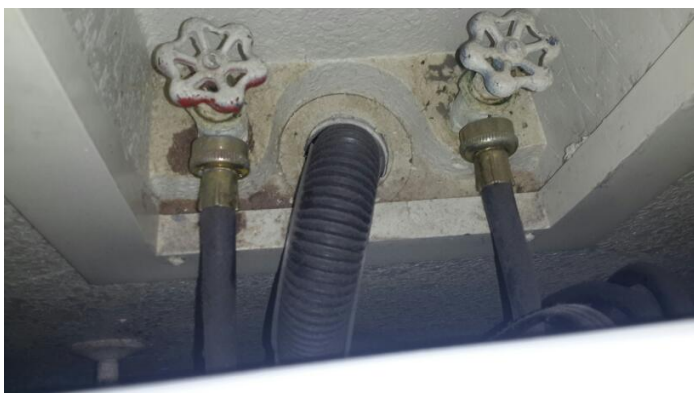
3.6 - The water supply to washing machines is commonly left on, and the rubber hoses that are commonly used to supply water can become stressed and burst. For this reason we recommend replacing all rubber supply hoses with metal-braided ones that are more resilient.

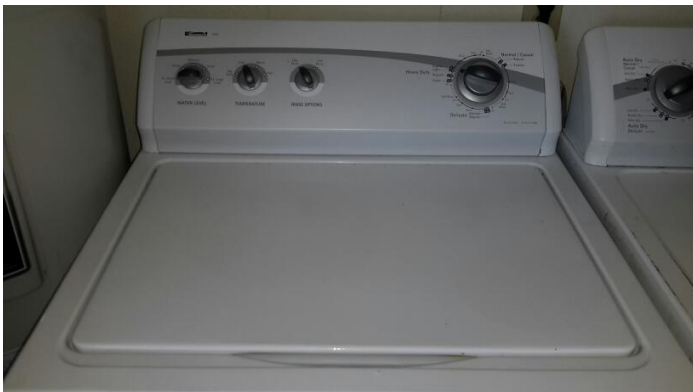
- 3.14 - At the time of inspection the washer was working. It was ran momentarily on one cycle and appeared to be working correctly. This is a limited washer inspection and you should ask the seller about all the appliances and ask about any issues.

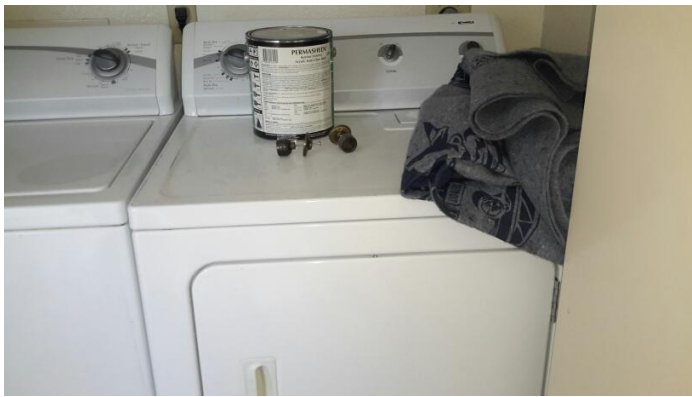
- 3.15 - The dryer was briefly tested and produced heat and appeared to be working on at least one cycle. Efficiency or capability was not tested.  
This is a limited Dryer inspection and you should ask the seller about all the appliances.

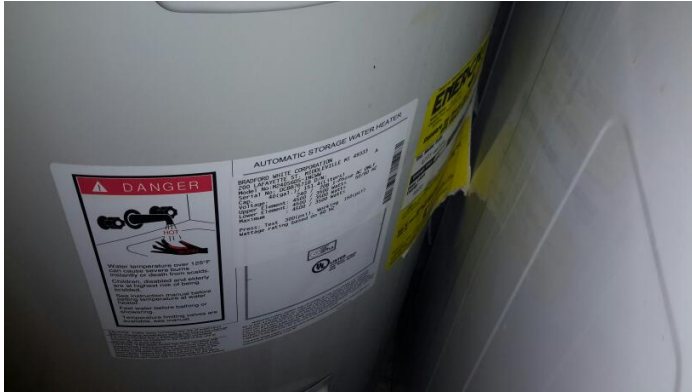
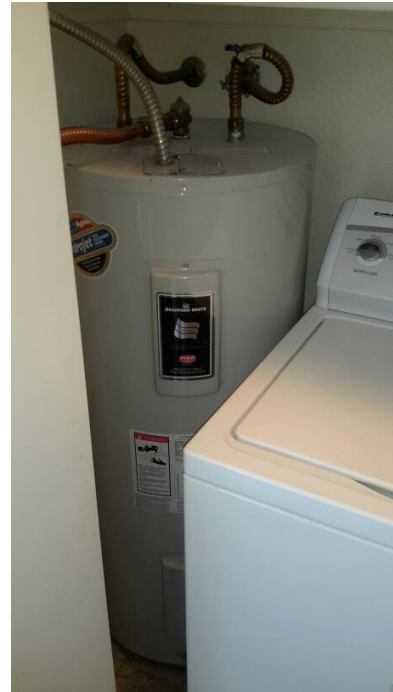
4.2 - Hot water is provided by a 2007, 40 capacity, Bradford-White brand electric water heater located in the laundry room.

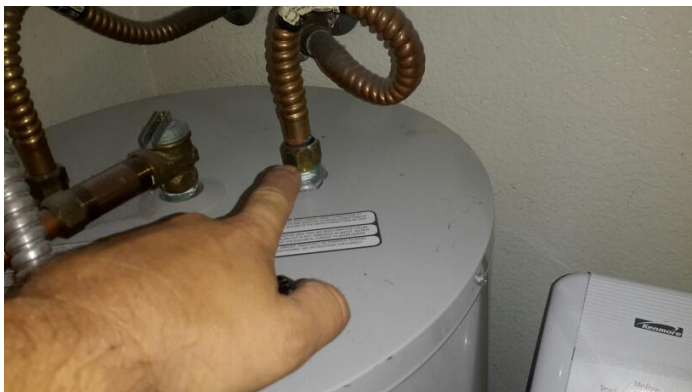
4.5 - There is a leak at the water connector on the inlet side, which should be repaired by a plumber.

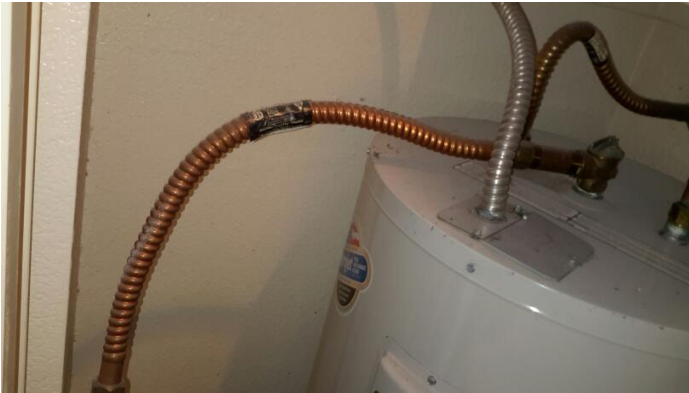
4.6 - The discharge pipe from the relief valve includes a flexible line and should be replaced with a solid copper discharge pipe. This is because flexible lines can become kinked and possibly prevent the relief valve from working properly in the event it needs to release temperature or pressure and may cause a dangerous situation.

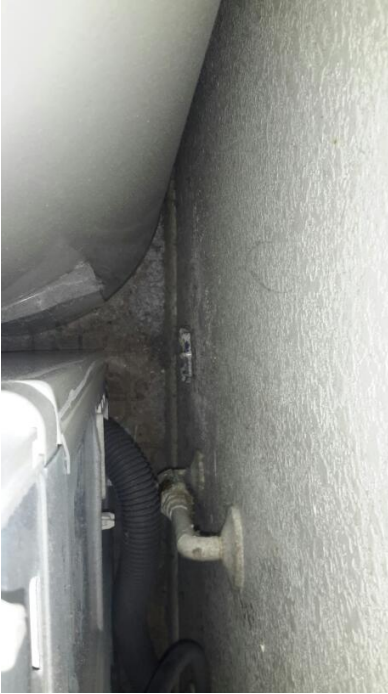
4.12 - The house water shut-off valve is located behind the washer. The house water shut off valve is an older style and less reliable gate type valve. Since main shut-off valves are operated infrequently, it is not unusual for them to become "frozen" or stuck in place over time. They often leak or break when operated after a period of inactivity. For this reason main shut-off valves are not tested during a home inspection. We suggest caution when operating shut-offs that have not been turned for a long period of time. All shut off valves and angle stops should be turned regularly to ensure free movement in case of emergency. Further evaluation and service as you feel necessary is recommended from a qualified plumber before the close of escrow.

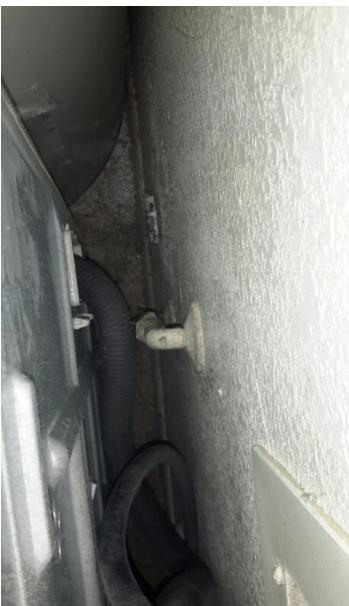
4.13 - There is a water connection behind the washer that is corroded that should be evaluated and repaired as necessary.

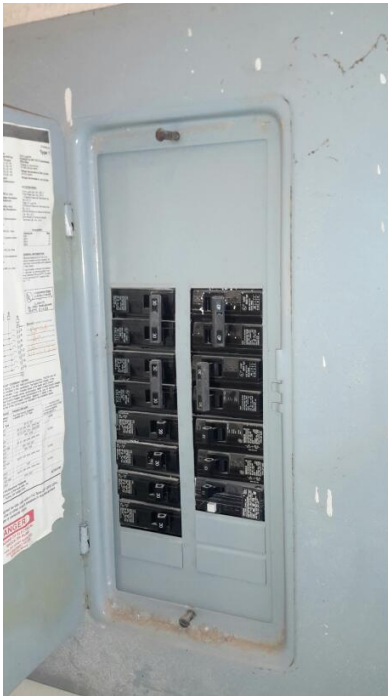
6.5 - The residence is served by a 100 amp, 120/240 volt I-T-E brand breaker panel located in the In the exterior storage area.

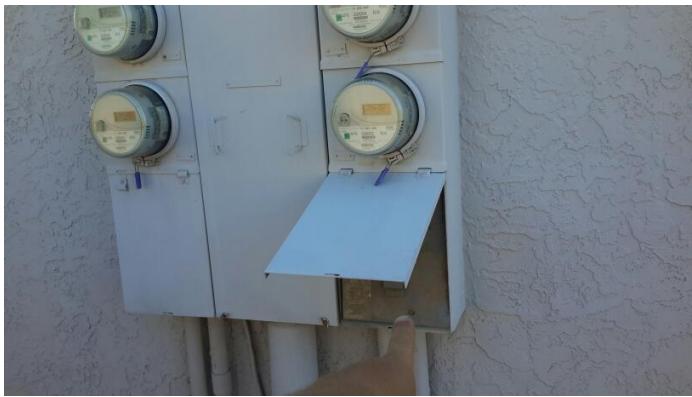
6.6 - The panel main disconnect is at the meter face.

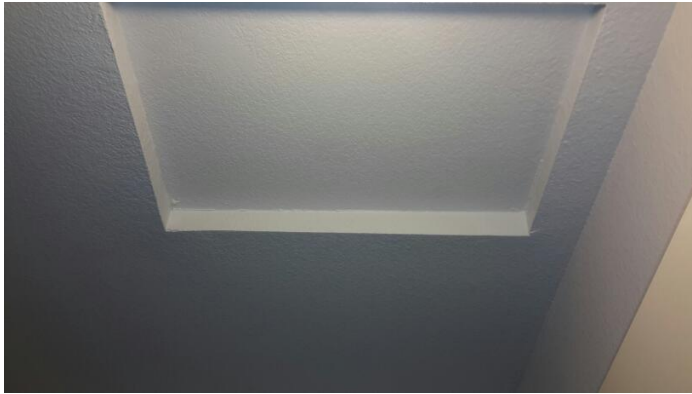
7.1 - The attic in the master bedroom closet and the outside hatch are painted, caulked shut. We recommend opening the hatches to allow access to the attic for viewing.

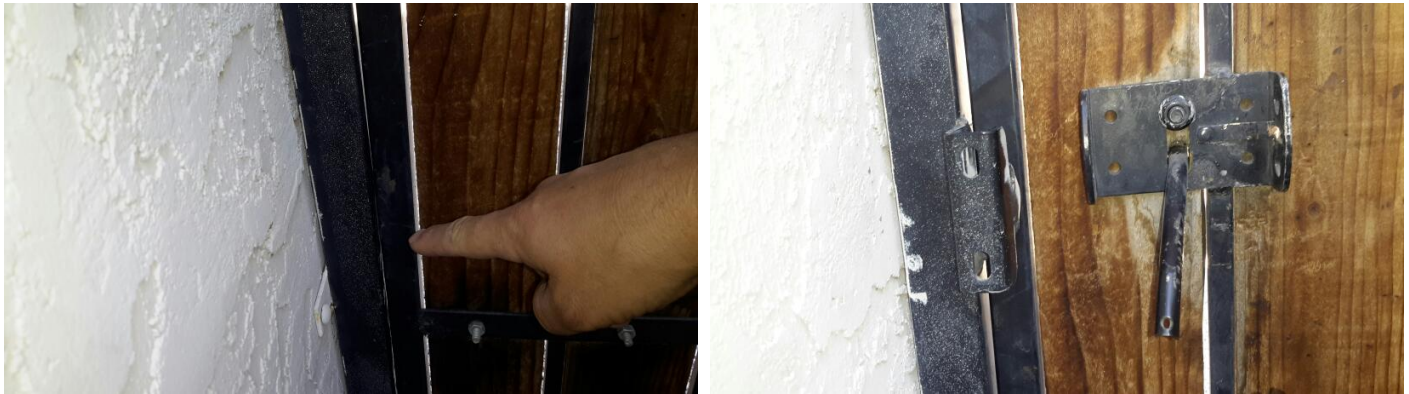
8.4 - The side gate is difficult to operate and needs service to open, close and made to latch.

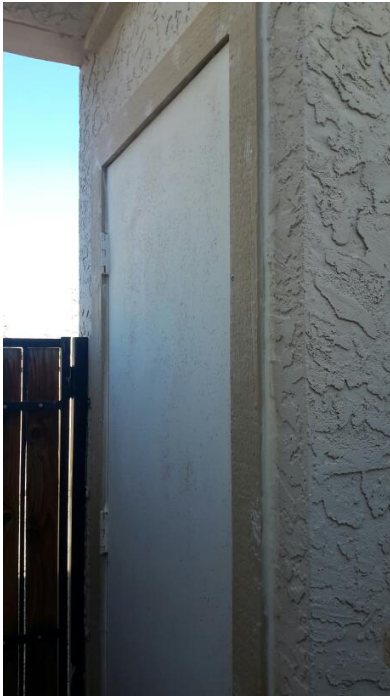
8.10 - Picture of shed

8.11 - There is moisture intrusion by the exterior storage area that should be evaluated and repaired as necessary

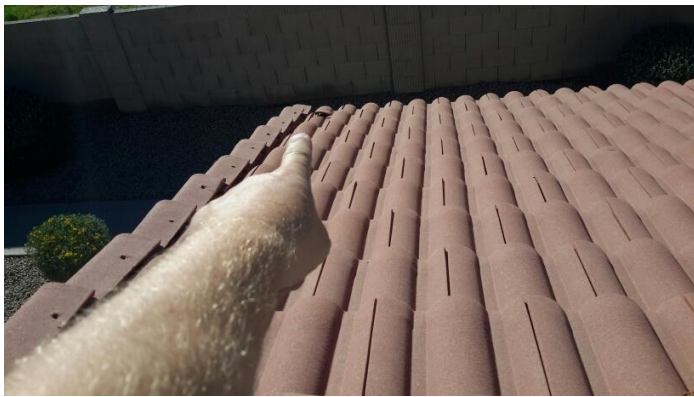
9.2 - Viewed at least 1 cracked roof tiles that should be evaluated and repaired or replaced as necessary by a qualified roofer or technician. These issues should be repaired to help prevent wearing of the protective layer beneath the roof covering or possible moisture intrusion within the residence.

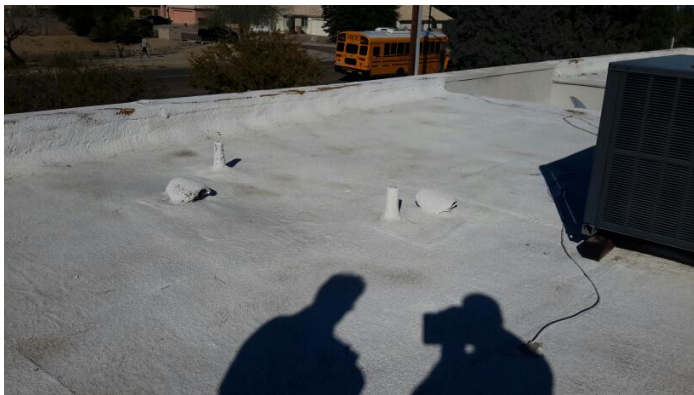
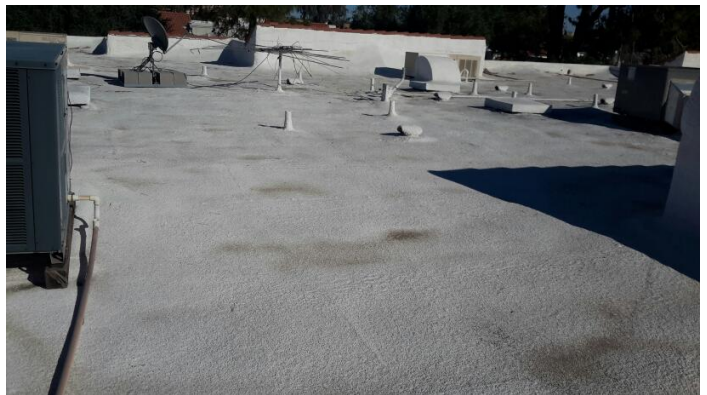
9.4 - The roof and its components were evaluated by walking on its surface.

9.5 - The foam roofing material is deteriorated and you should talk to the HOA about who's responsible to get the roof repaired and when it is scheduled for repair.

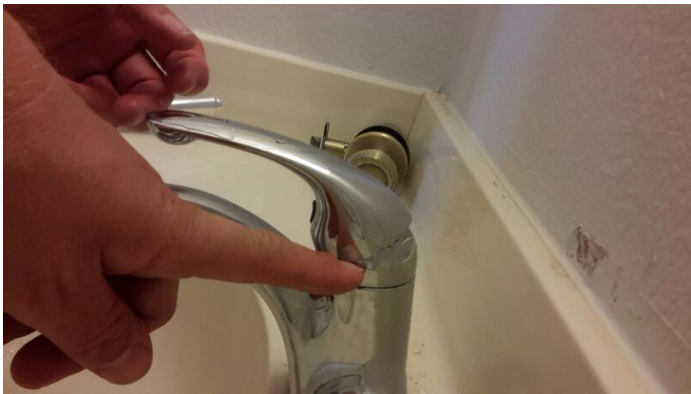
11.7 - In the master bathroom the sink faucet leaks around the stem while in use, and should be repaired or replaced as necessary to help prevent moisture damage.

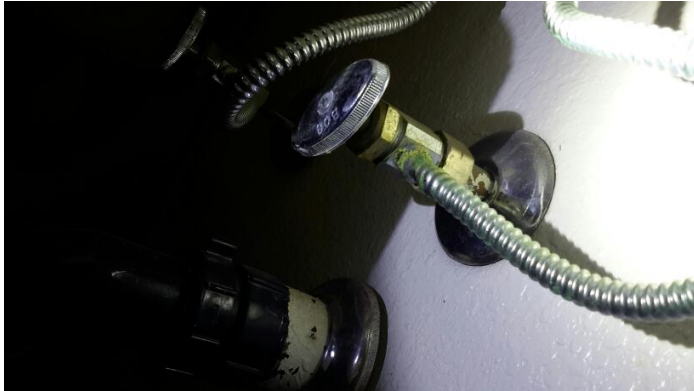
11.8 - In the master bathroom corrosion and/or mineral build-up was observed on the master bathroom Right and left shut-off valve . This corrosion or build-up may prevent the shut-off valve from working properly, especially if emergency shut-off is needed. I recommend a qualified, licensed plumber should evaluate and repair or replace this valve or connection as necessary.

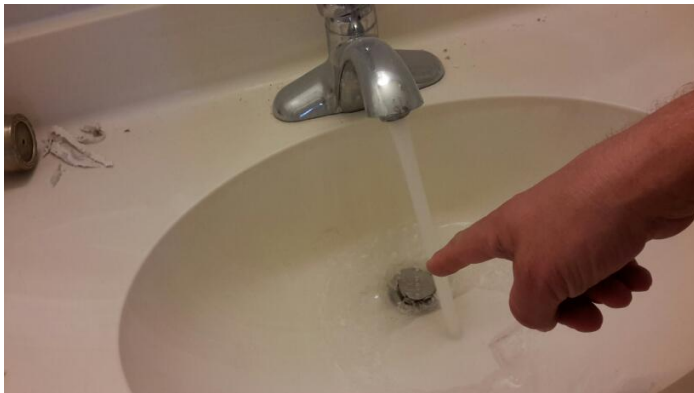
11.9 - The master bathroom mechanical sink stopper is missing or incomplete and should be serviced or replaced as necessary.

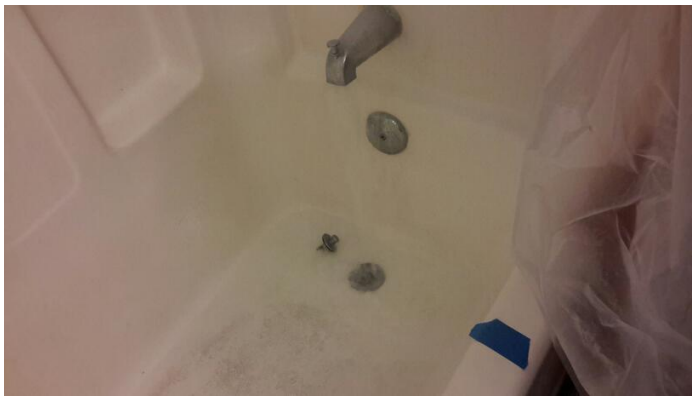
**Tub**  
11.10 - The master bathroom's tub stopper is missing or incomplete, and should be repaired or replaced.

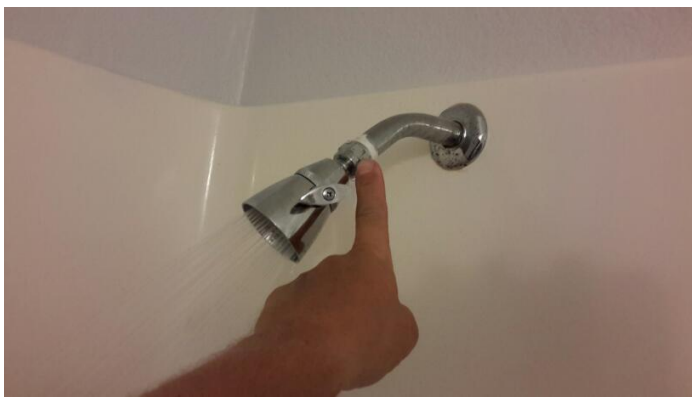
11.11 - The master bathroom shower is dripping from its connection point and should be repaired to not drip.

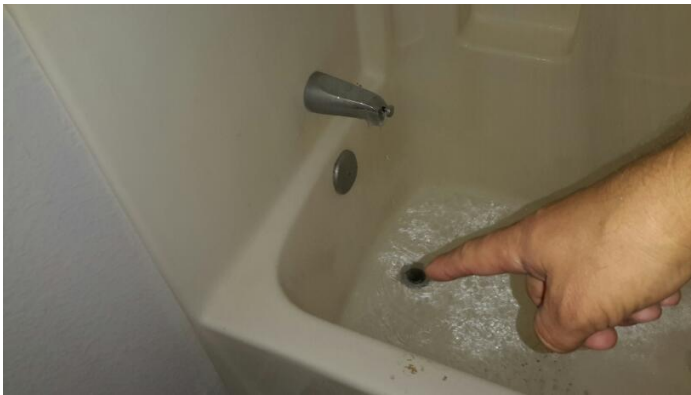
11.24 - In the hallway bathroom the mechanical tub stopper is missing or incomplete and should be repaired or replaced.

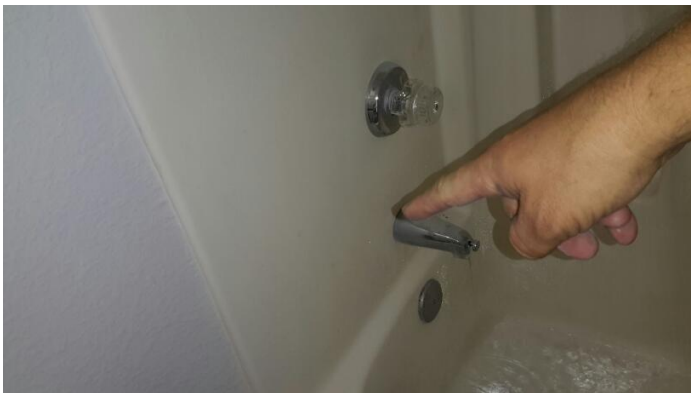
11.25 - In the hallway bathroom I recommend caulking or sealing around shower valves and faucets etc to help prevent moisture intrusion behind or into the walls. Monitoring these areas is also recommended to help ensure an adequate seal is in place.

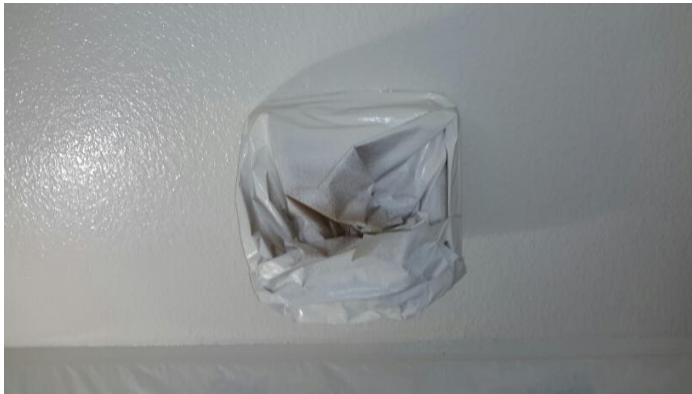
11.28 - The hallway bathroom exhaust fan is functional but noisy. You may wish to consider upgrading it for a quieter one.

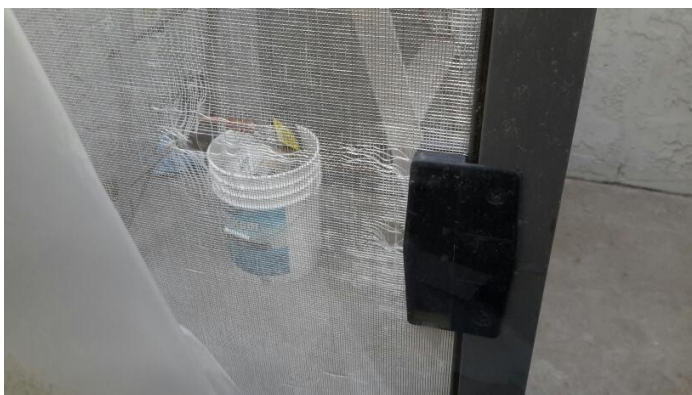
12.10 - Exterior door screen is off the tracks and has damage to the screen that you may want repaired.

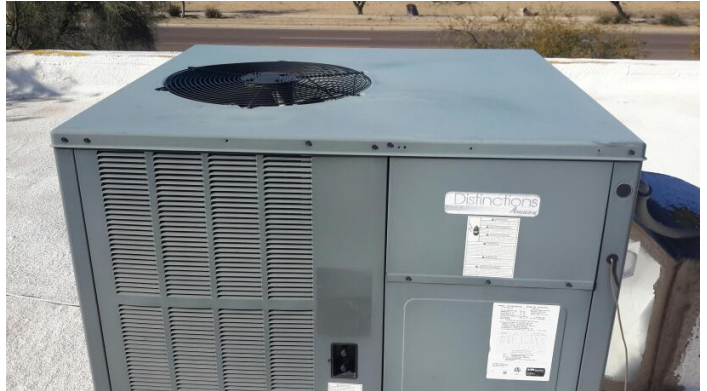
13.2 - Central heat and air-conditioning are provided by a packaged 2013, 2.5 total ton capacity, Amana brand heat pump located ion the roof.

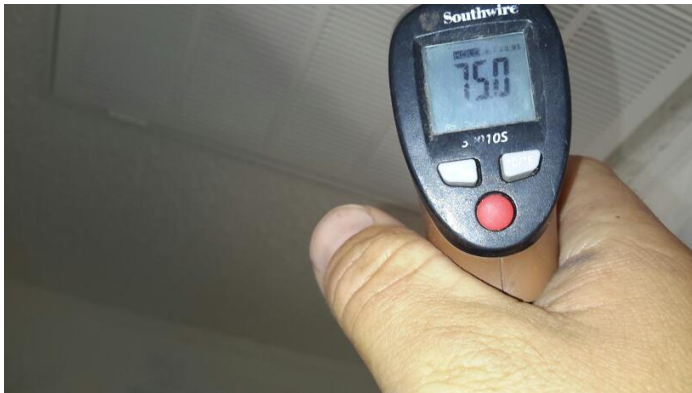
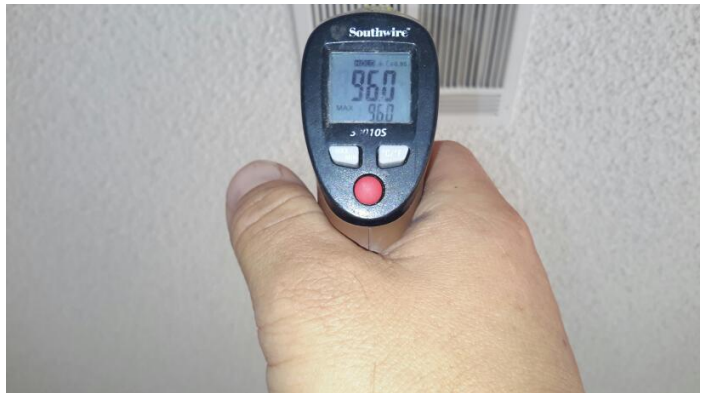
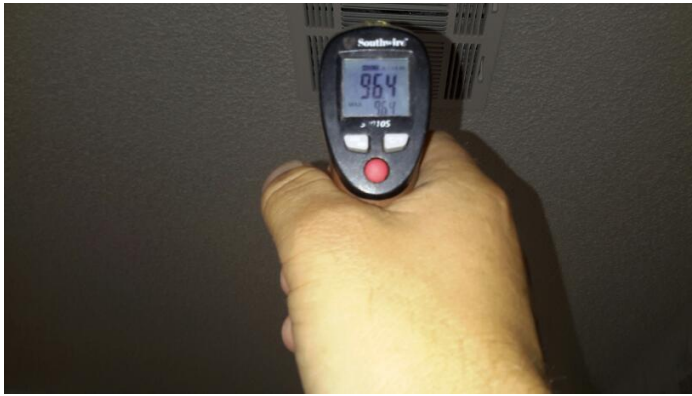
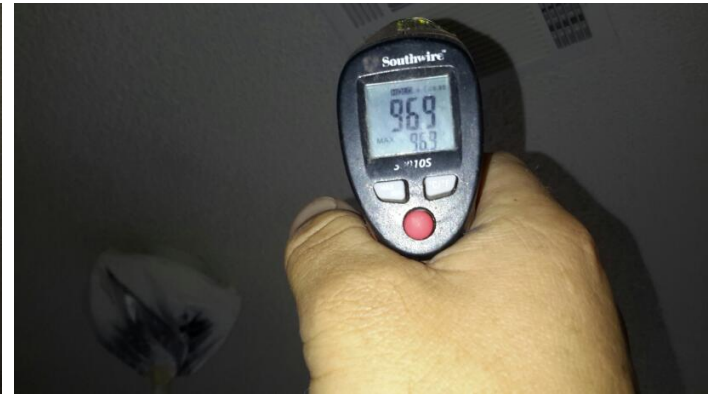
13.4 - The heating responded and achieved an acceptable differential temperature split between the air entering the system and that coming out. 21.9 degrees difference noted with a split of 96.9 degrees at the supply air registers and 75 degrees at the return.

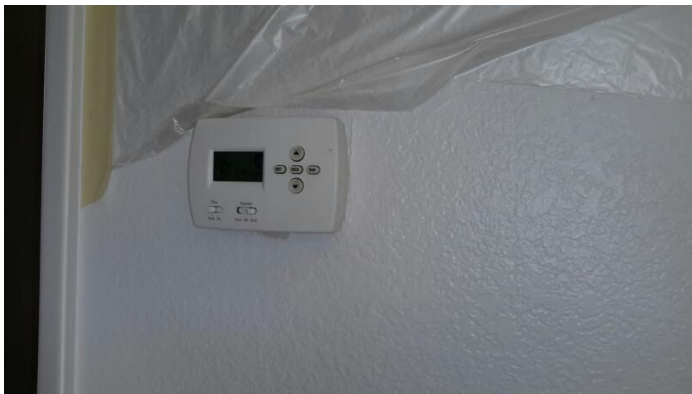
13.9 - The thermostat was located in the main hallway

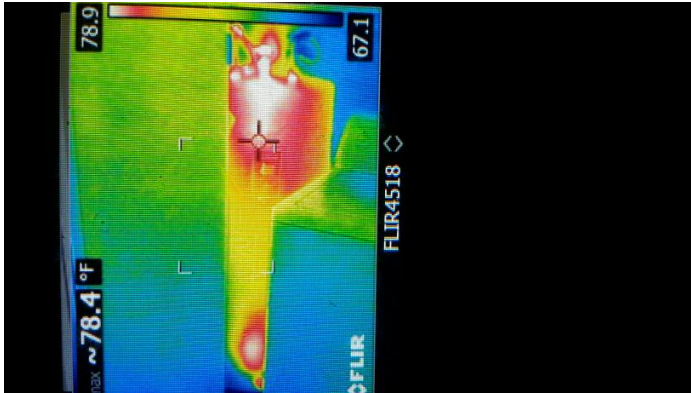
14.2 - This thermal image of the Electric water heater appears to be working properly, with no signs of leaking.
