Buyer's Choice Home Inspections The Best Home Inspection At The Best Price

Confidential Inspection Report

1343 W Glenmere Dr Chandler, AZ 85224

Prepared For Pam & Steve Sellers

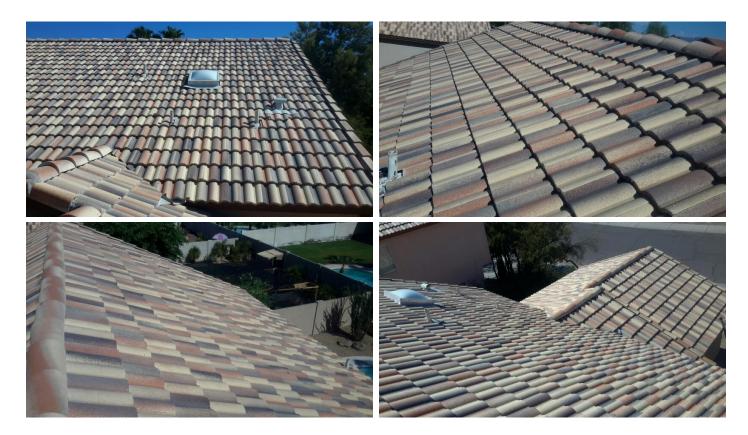
9.2 - The roof and its components were evaluated by walking on its surface.

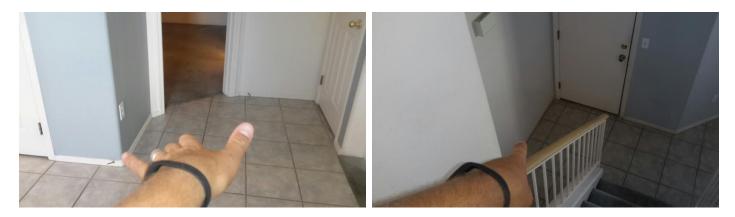
10.3 - One or more door stops throughout the home should be repaired or installed as necessary.

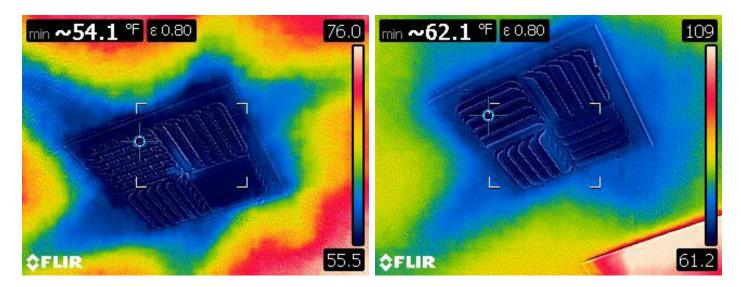
15.4 - The air conditioning unit responded and achieved an acceptable differential temperature split between the air entering the system and that coming out.

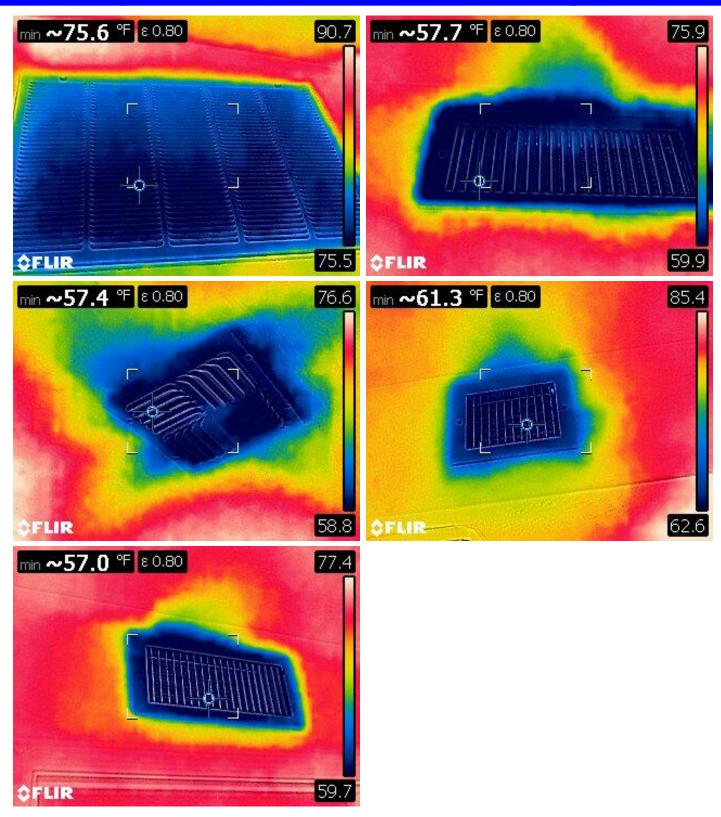
15.5 - The heat pump responded to a request for cooling, but was not tested on the heat cycle because the ambient temperature is too high and to do so could have damaged the coil.
